NASA Contractor Report 191181

Isothermal Fatigue Mechanisms in Ti-Based Metal Matrix Composites

Bhaskar S. Majumdar and Golam M. Newaz
Battelle Memorial Institute
Columbus, Ohio

September 1993

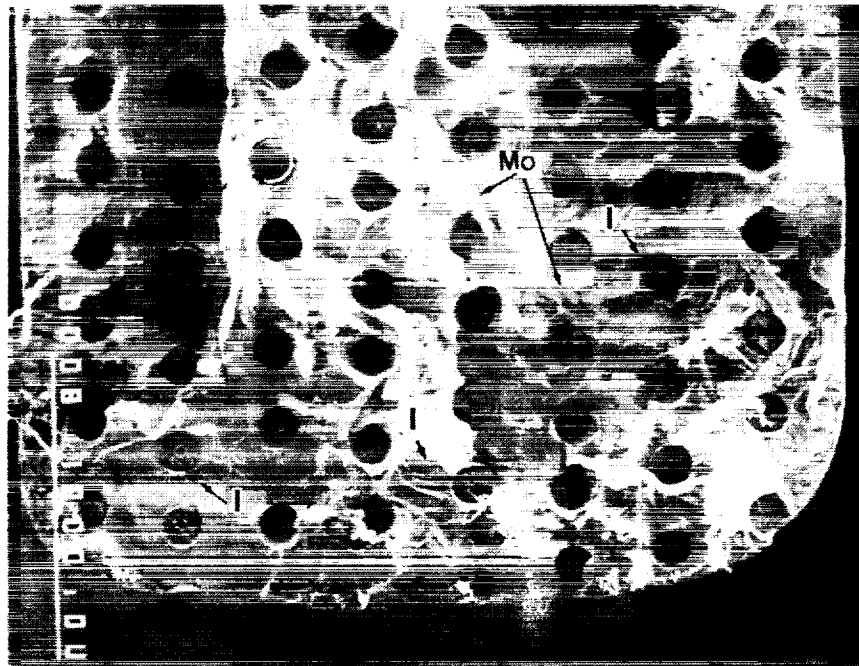
Figure 21. Fractograph of a MMC-15 specimen, cycled at a strain range of 0.45% at RT. The fracture surface revealed large fatigue crack areas, with multiple cracks nucleating from around the fiber; a radial crack initiating from the reaction zone around the fiber is indicated by "I".

Figure 21 is a micrograph of the fracture surface of a specimen cycled at a strain range of 0.45%. The arrows (I) point to a number of radial fatigue cracks emanating from the reaction zone of the fiber. These cracks were transgranular with a fine faceted crystallographic appearance (see Figure 22), and only in a few areas could classical fatigue striations be observed; in some areas (particularly at Mo-ribbons) there were river markings suggesting even a quasi-brittle type of fracture. As shown in Figure 20b, the surface of the specimen showed that cracks tended to follow the slip traces, likely because of the strong planar character of slip, and the fine faceted appearance resulted as the crack wove in and out of the different parallel slip bands. A similar crack morphology was observed for the matrix specimens, although here there was a greater incidence of striations and relatively less incidence of a flat and quasi-brittle type of appearance as was observed in the MMC specimens. It is not clear whether the matrix constraint of the fibers and carbon diffusion from the fibers into the matrix (during processing) play any role in producing the

For specimens fatigued at 0.3 percent strain range and higher, Mo-weave cracks were observed on the fracture surface (see the wavy regions indicated by the arrow marked Mo in Figure 21). The presence of Mo-weaves on the fracture surface suggest that they likely had a detrimental influence on both crack initiation and propagation, although it is difficult to quantify the effects without testing specimens that do not have Mo cross weaves. The amount of Mo-weaves on the fracture surface generally increased with strain range, and may be indicative that the weaves played a more dominant role at higher strains. This could explain why MMC life was significantly shorter than matrix life at the higher strain ranges in Regime 2, where matrix fatigue crack was still the dominant damage mechanism; however, confirmatory experiments are necessary. It may be worth pointing out that monotonic tension tests had revealed [1,6] a detrimental influence of Mo-weave on MMC fracture. Also, fatigue experiments performed at 650 C on SCS6/Ti-15-3 MMCs, with Ti-Nb and Mo-weaves (the two weaves were present in the same panel), showed [31] that specimens with the Mo-weave had almost a 200 % reduced life compared with specimens containing the Ti-Nb weave. Thus, there is sufficient evidence to suggest that Mo-weaves are areas of weakness, both in monotonic tension and in fatigue. At strain ranges below 0.3%,

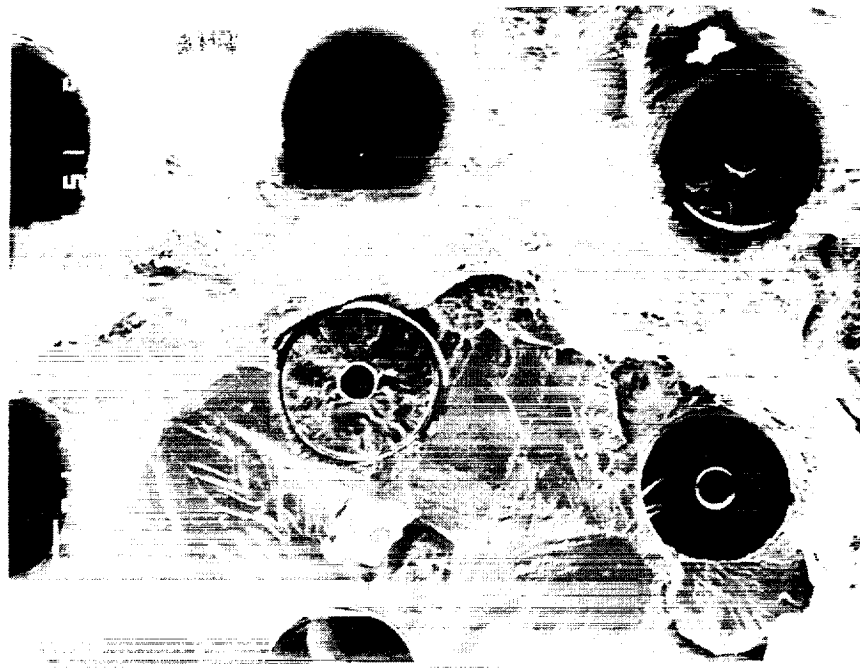
Figure 23. Fractograph taken near the transition regions between fatigue crack growth and fast fracture, in a MMC-15 specimen cycled to failure at RT.

In the fast fracture region, there was extensive fiber pullout. The transition between the fatigue and fast fracture regions was quite abrupt. This is illustrated in Figure 23, which shows a ductile dimple type of failure morphology in the fast fracture region (top half of micrograph) compared with a crystallographic type of fracture in the fatigue crack growth region; note also the flat and featureless (almost quasi-brittle) regions in some areas of fatigue fracture.
